CASE REPORT

A late complication following the insertion of hydrogel breast implants

Titus S.T. Adams*, Timothy Crook, Michael A.M. Cadier

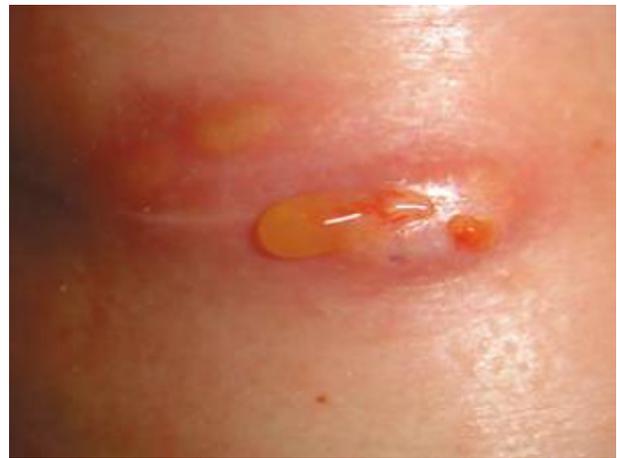
Two weeks prior to her plastic surgery appointment, the patient developed a discharging, nodular sinus from the inferior aspect of the right breast along the original infra-mammary scar (Fig. 1). On examination, both breasts were soft and non-tender and the patient was afebrile.

Figure 1 Right breast infra-mammary scar with discharging sinus of hydrogel implant contents.

Her white cell count was $8.0 \times 10^9/l$ (range: 4.0–11.0). Following these findings, both hydrogel implants were removed and found to be intact, capsulectomies performed, and bilateral replacements with silicone gel implants.

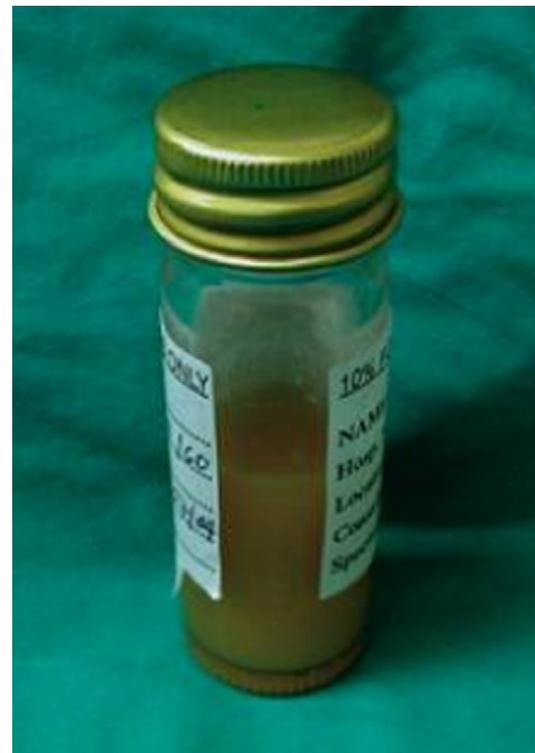
The right infra-mammary scar was excised and sent for histology. On removal of the intact implant, copious amounts of yellow/green, non-purulent fluid was collected from the right breast pocket (Fig. 2). Histologically, the lumpy

Figure 2 Contents of hydrogel implant drained from within capsule.

infra-mammary scar revealed extensive foreign body giant cell reaction and fat necrosis, consistent with a foreign body giant cell reaction to leakage of hydrogel material through the intact wall. The adjacent fibrous capsule contained large numbers of foamy histiocytes. The patient went on to make an uneventful post-operative recovery.

infra-mammary scar. This phenomenon may be explained by the leakage of the osmotic hydrogel filler from the implant into the surrounding capsule. A number of studies have shown that hydrogel breast implants can swell in vivo^{7,8} with some implants increasing in volume up to 38%, which was cited as the main reason for their removal after an average of four years.⁹ It is likely that the increase in the patient's right breast in this case was caused by her Hydrogel[®] implant undergoing spontaneous, direct degradation with content leakage into the surrounding capsule. There is no data in the literature concerning the degradation potential of hydrogel implants or to the potential toxicity of any degradation products on the surrounding silicone shell or biological tissues.
